Evaluation of Revitalization Strategy: A Case Study of Barukoto Traditional Market in Bengkulu, Indonesia

The Barukoto market is a shopping center that was popular in the 70s to the late 90s in the city of Bengkulu. As time went on, Barukoto Market experienced a deterioration in environmental and physical quality so that it was neglected in several parts. The decline in consumer segmentation that came also decreased, due to the emergence of more modern and representative new shopping centers, such as hypermarkets and shopping malls. To increase the vitality of the area, it is necessary to revitalize activities so that they can create a renewal of the quality and physical quantity of buildings and can increase the property value of the area. To answer the purpose of the study, using qualitative descriptive analysis techniques, supported by quantitative assessment, through the scoring method. The revitalization criteria obtained are, from the location aspect 79.45% <80%, this is categorized as a potential enough to do revitalization activities. Furthermore, from the aspect of the physical study, an assessment of 48.50% <61% and management aspects with a value of 50% <61 %.

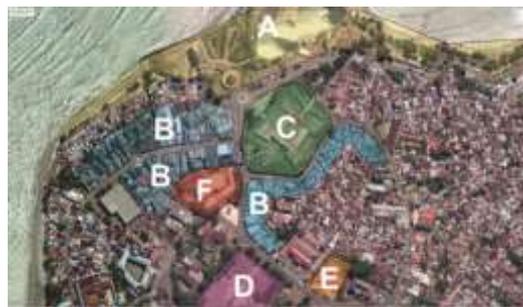
Figure 4.1: Location Characteristics of the Surrounding Area

The location of the study can be seen in figure 4.1, with the object of research being around tourist objects in accordance with the tourist attraction of each object in the form of:

- Figure A : Nature Tourism (beach), Recreation (resort)
- Figure B : Objects of the Chinatown History Building
- Figure C : Objects of the Marlborough Colonial Heritage Building
- Figure D : Bengkulu's Town Square (place of ritual culture for Tabot)
- Figure E : Tradisional house of melayu culture in Bengkulu
- Figure F :Pasar Tradisional Barukoto.

The location image discussed also has relevance to the identity of the area around the object of research. If you look at figure 4.1 above, it can be identified the characteristics of the area through the function of the type of building and architectural elements in the area. The characteristics of the area can be explained as follows:

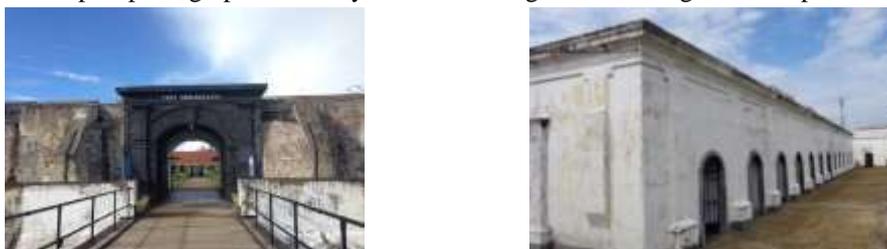
Figure 4.2: Visual Views of Fort Marlborough

- Symmetrical plans are rectangular, with bastions or guard buildings in every corner of the building
- Has an underground tunnel leading to the coastal area and regional building (governor's house)
- The center of the building is inner court
- Forming architectural elements in the style of colonial buildings, such as arches, arched windows, roofs and many European ornaments.
- The scale of the building is monumental, different from the surrounding buildings.

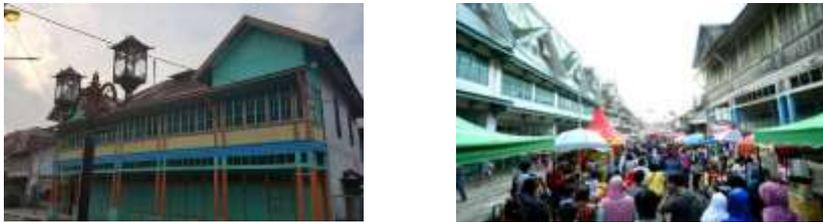
Figure 4.3: Views of Chinatown as an Old City

- Contains a function of the typology of shop houses and residential buildings (row building, extending backward, building height 2-3 floors,)
- Has building functions in the form of temples and buildings for other social activities.
- Affected by the traditional Chinese architectural style with those in China with gable roofs at the peak.
- Chinese-European architectural style, a combination of architectural elements with symmetrical patterns of window and door openings.
- Alkulturation with Chinese architecture / with local locality, can be seen from the facade shape with window openings, wooden doors and niche ornaments typical of Melayu's culture.

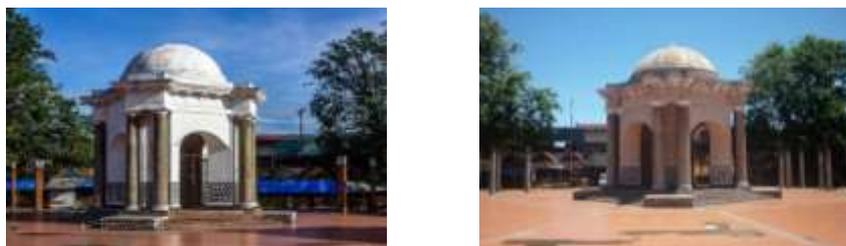
Figure 4.4: Visual appearance of Tugu Thomas Parr

- The function of the building as a monumental building.
- Around the building there is an open space used for community activities.
- Plans are octagonal or octagonal
- Dome shaped roof
- There are pillars with architectural elements of colonial style.

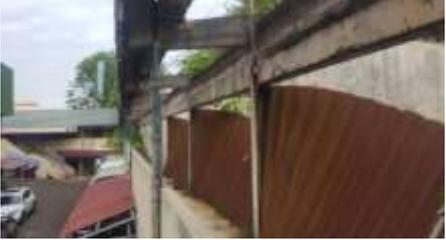
1st floor kiosk (above)	Information

<ul style="list-style-type: none"> The condition of the first floor kiosk is 60 units with a kiosk area of 25m²-30m², currently it is not used by traders due to inadequate physical conditions. Some building elements such as floors, walls and roof are not maintained. Of the total 95% of the stall floor area in Block A it cannot be used Rolling door doors rust and break The condition of the columns and building blocks of some parts experiencing hair cracks, vertical cracks and deflection Roofs and building ceilings which were destroyed 60% and cannot be used. Building floor, many floor tiles are broken, apart from the part. Stall rolling door doors that cannot be used properly. Wall paint fades

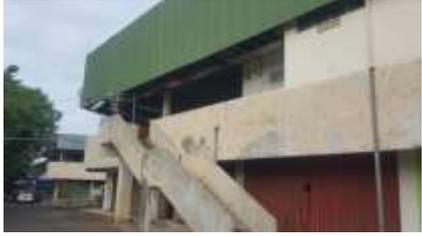
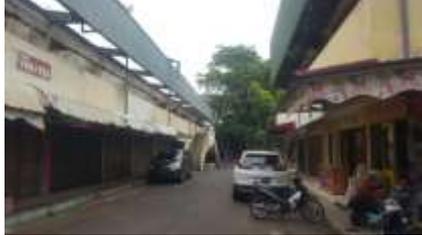
Ground Floor Stall	Information

<ul style="list-style-type: none"> Ground floor is still possible to be rented by traders, most traders are placed on the ground floor. The roof and paint color of the building that began to fade gave the impression that the building of the Barukoto Market was not maintained. Ceramic floor coverings and concrete rebates are cracked and broken Some floor kiosks with a size of 20m²-30m² basic m² in Block A and B are not occupied by traders.

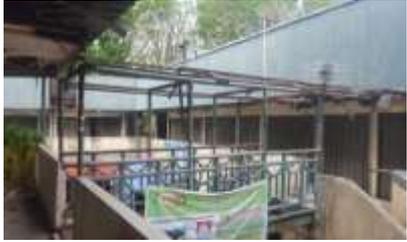
<p>Pedestrian bridge</p>

<p>Information</p> <ul style="list-style-type: none"> • The condition of the pedestrian bridge that connects the kiosks is not suitable for function and use. The ceiling and the canopy roof are not functioning properly. • Bridge crossing is 1 unit / 1 point, cannot function optimally, to serve consumers who uphold.
<p>Corridor</p>
