FATIGUE LIFE PREDICTION FOR WOVEN GFRP COMPOSITE LAMINATES DAMAGED WITH HEMI SPHERICAL IMPACTOR

Abstract- Composite materials have become viable alternative to metallic structures in aircrafts and automotive sectors. These structures prone to impact and fatigue loads. The objective of this paper is to investigate the effect of low velocity impact and tension-tension type fatigue on woven glass fibre/epoxy polymer composite laminate. The impact damage and fatigue life is inter-linked in this work. The laminates were prepared by hand layup process having a thicknesses; 2mm. The specimens were subject to low-velocity impact at different energy levels (7.85, 15.7 and 23.54 Joules). The fatigue test was conducted for both impacted and non-impacted laminates, by keeping the stress ratio, R value at 0.1 and frequency at 3 Hz. The results indicate that the impact velocity is very much influential on the fatigue life of composite laminate. Further the results indicate that the fatigue life of the 2mm thick impacted laminates was drastically reduced. A comparative study is also attempted to understand the behavior of impacted laminates subjected to fatigue loading.

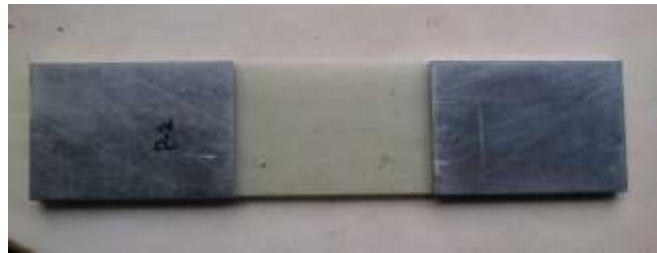
Fig.1 Specimen used for FATIGUE TEST

For the fatigue test the specimen is prepared as per ASTM D3479 test STD it is shown in the fig2.1. Aluminum is used as tab is done at edges of the specimen by glowing. The servo hydraulic computer controlled Fatigue testing machine is used [19]. Two jaws are operated by hydraulically because it holds the specimen very rigidly and handling is also easy.

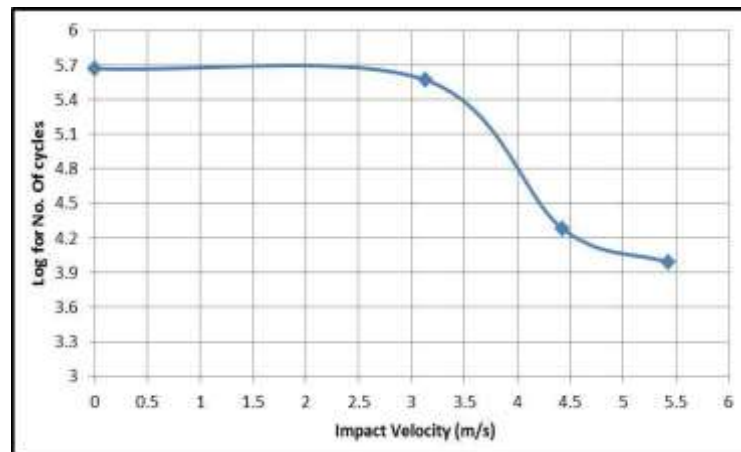
Fig 3 Log of No. of cycle's v/s Impact velocity (m/s) for fatigue life time curve, under Tension-Tension fatigue loading for 2 mm thickness

Fig 3.2 shows Log of cycle's v/s Impact velocity (m/s) for fatigue life time curve, under Tension-Tension fatigue loading for 2mm thickness of woven glass fibre reinforced polymer composite laminates with and without impact loadings respectively. The impact damage decreases the fatigue life of the composite laminates. At the low velocity (3.132m/s) the impact damage has less effect on fatigue life compared to other velocities and so in the Log of cycle's v/s Impact velocity curve. The fatigue life was determined for the laminates under impacted & unimpacted laminates of 2 mm thick woven glass fibre/epoxy polymer composite laminates low velocity impact of 3.132m/s, will not much effect on the fatigue life of the laminates at the impacted and unimpacted, there is small variation on the fatigue life compared to the other velocity's 4.429 & 5.425 m/s. The fatigue life at these impact velocities is very small, because which cause the fibre damage in the laminates during impact loading. Because there is very less damage on the fibre which will not affect much on fatigue life, the damage of fibre and matrix is more in 2mm thick laminates this will influence on fatigue life. The matrix and fibre damage is high in the 2mm thick laminates at 4.429 & 5.425 m/s impact damage then compared to 3.132m/s so this is not much effect on the fatigue then other two impact velocities.

In each fatigue cycle the tensile fatigue load caused due to local buckling and displacement of the impact damage site. This was visible from front and back faces at the speed of fatigue cycling (3Hz). The amplitude of moment was in the range of 2mm. In the tension phase of fatigue cycle the crack has been started from the impacted edge and after a few hundred cycles the cracks distributed to edges of the laminates. In later stages of fatigue test some of surface plies would delaminate from the damage plies and buckle during the tension phase of the cyclic loading. This delamination buckling would occur predominantly on the back face through occasional on the front face close to the impact damage site. The crack is incremented throughout the width of composite laminate. The crack was elongated there is a reduction in the stiffness of laminate. It would appear that matrix and Fibre failure increases gradually within the impact zone, it leads to the reduction in the stiffness.
